OPL- CRWN-038

Description: Replacing damaged rubber seal side lift up windows

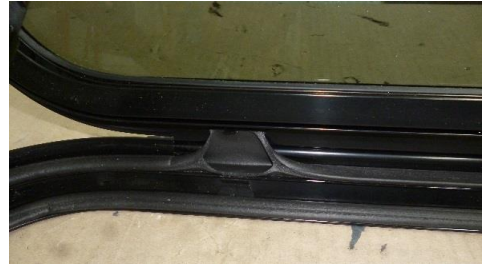
1 Remove damaged seal

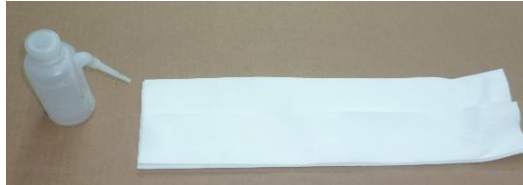
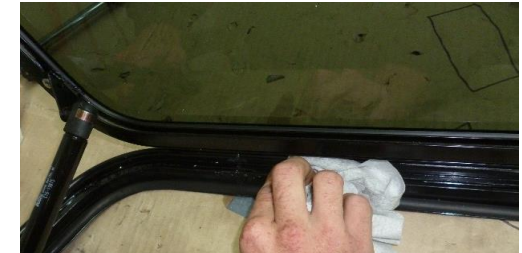
2 Remove residue adhesive with alcohol

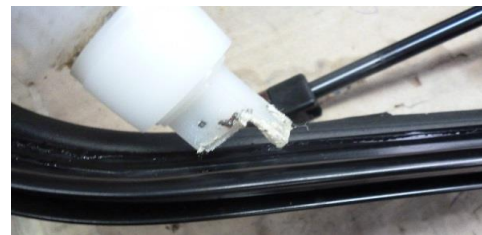
3 Apply 3M primer to surface in preparation for new seal C5-55-6074

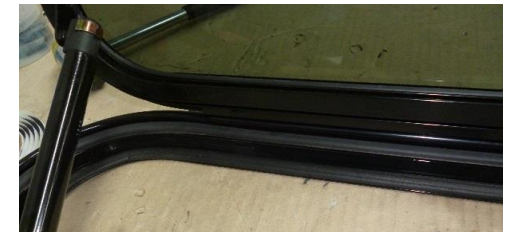
4 Remove protective tape from seal and stick seal to window frame moulding it around the corners of the frame.
